Recommendations for Enhancing Avon Hall Pond

Presented to the Town of Washington, Virginia
By RappFLOW
December 2008

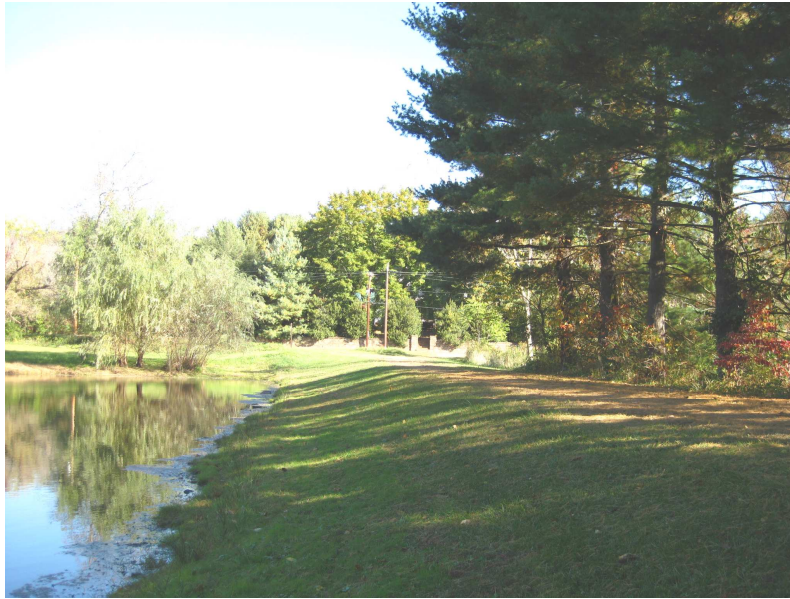
Picture of the embankment and driveway to Avon Hall Pond. Photo by Virginia Valentine

The embankment of the Avon Hall dam contains a number of large white pine trees along with other woody vegetation growing on the dam. Woody vegetation is inadvisable on pond dams due to the fact that it can weaken the structure of the embankment. Water in a pond is always looking for a way out. Large plant roots and animal burrows are ways that water can escape. A good maintenance check of a dam is to look for seepage points on its downstream side. Seeping areas are an issue because they weaken the structural integrity of the dam, and during large rain events with the added pressures of more and more water can lead to a dam failure. The volume of vegetation growing on the Avon Hall dam prevented us from evaluating any seepage points. An additional danger to the dam is the possibility of the white pine trees overtopping. During high wind events trees can fall over, exposing their roots and undermining the embankment.

Clearing the dam embankment of woody vegetation presents the biggest maintenance issue we found at Avon Hall Pond. Removing trees and shrubs from the embankment will significantly increase the longevity of the structure. The large white pine trees currently growing in a row across the embankment should probably be removed before they cause any damage. In addition the ground hog burrows should be filled in and if ground hogs continue to burrow, it may be advisable to trap and relocate them. As stated near the beginning of this report, the current level of vegetation growing on the embankment masks any points where water could be seeping out. Clearing out this vegetation and maintaining grass will allow the town to monitor for any issues more easily.

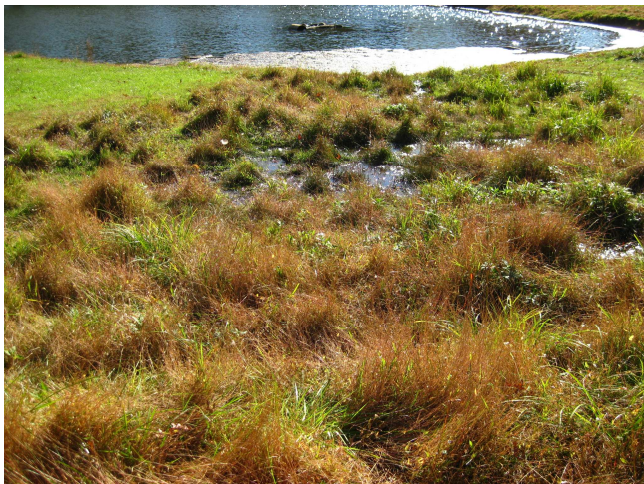
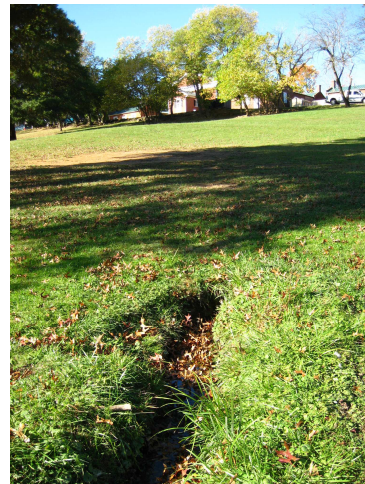
We observed at least four sources feeding water into the western edge of the pond. Most of these sources consist of springs seeping out of the ground at the toe of the slope, but one of the sources is being feed by a pipe of an unknown origin. This pipe may be an old clay tile pipe used for drainage purposes, but further investigation should be made.

The photo on the left is an image of one of the springs feeding Avon Hall Pond. On the right is a picture of the unknown pipe. Photo by Virginia Valentine

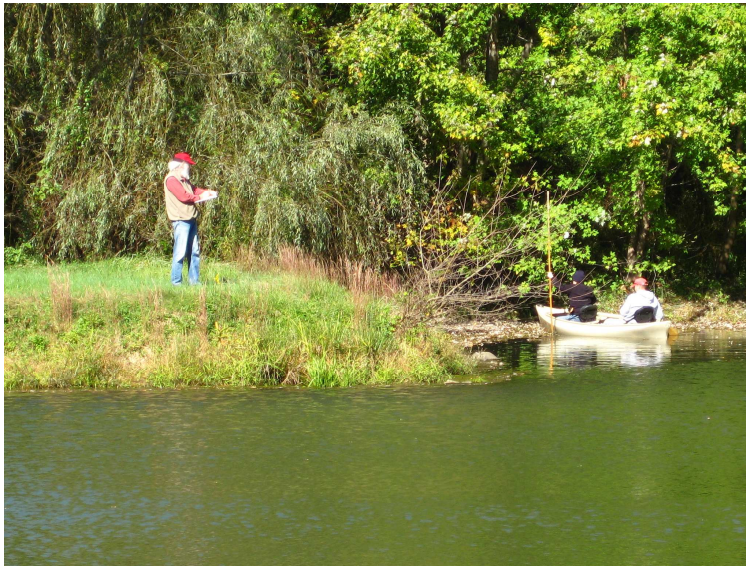
A contour map was created to delineate the depth of Avon Hall Pond by transecting a grid pattern across the pond and measuring the depths along the grid (Attached Sheet 2). On average the middle of the pond is 5 to 8 ft. deep with a maximum depth of 8.5 ft. at the over flow pipe. Pond depth is important because it not only affects the amount of water the pond can hold, but also impacts where and what kind of vegetation can be planted. While measuring depths, we also used a Secci Disk to measure water clarity. A Secci Disk is a brightly colored disk that is lowered into the water and the depth at which it cannot be seen is recorded. The device we were using had a maximum testing depth of about 3 ft. We measured several locations and found that we could clearly see the disk at three ft., meaning that the water is fairly clear and would provide enough light for the plants we are recommending. In our recommendations, we have created four zones for plants that are dependent upon water depth.

Virginia and B.J. Valentine relay depth measurements to Marc Malik who records the depths and later drafted the contour map. Photo by Pat Dorsey

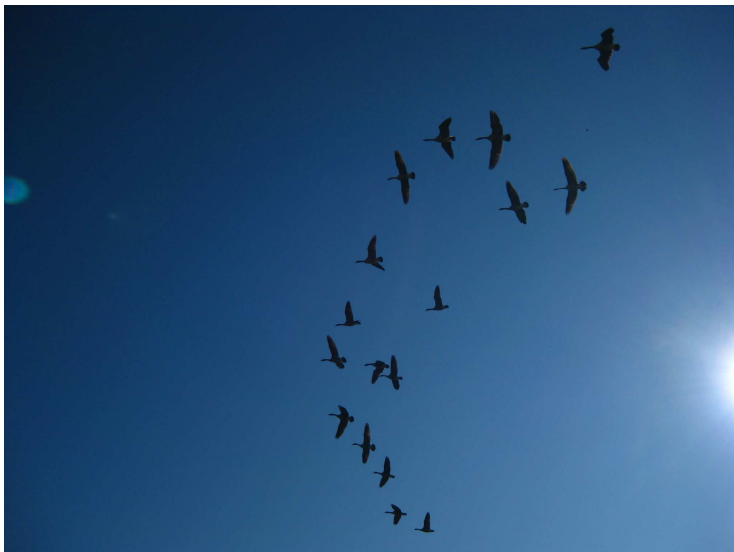
A species of wildlife that is most likely to be significantly impacting the site is Canada Geese. During one site visit we witnessed at least 34 Canada Geese on the water. The banks along the pond are littered with goose droppings and show bare patches in the grass which are further evidence of highly trafficked areas for geese. Our recommendations later on in the report will discuss ways to fight this problem because Canada Geese not only increase loading of nutrients into waterways and ponds but also are a source of bacteria.

Canada Geese trying to land during our field study at Avon Hall Pond.
Photo by Virginia Valentine

We believe that properly implemented vegetative buffer and aquatic zones should reduce resident goose populations. Canada geese congregate near ponds and lakes that provide easy access to nearby foraging areas (i.e. mowed areas). So, by allowing the riparian edge to grow up, a landowner reduces foraging areas and leaves geese more susceptible to attack by predators. The Cooperative Extension publication recommends reducing or eliminating all mowing of vegetation within 50-75 feet of the water's edge. The buffer we are proposing is not as wide as this recommendation. We believe that by reestablishing a smaller buffer the impacts of the geese should be minimized. If this technique does not sufficiently dissuade geese, other recommendations include scare strategies using visual (scarecrows, owl effigies), auditory (loud noises, pyrotechnics, recordings of distress calls), and physical deterrents (remote control vehicles, dogs, sprinklers). All of these techniques require that the landowner switch the tactics from time to time due to the fact that Canada geese can adapt easily to their environment.

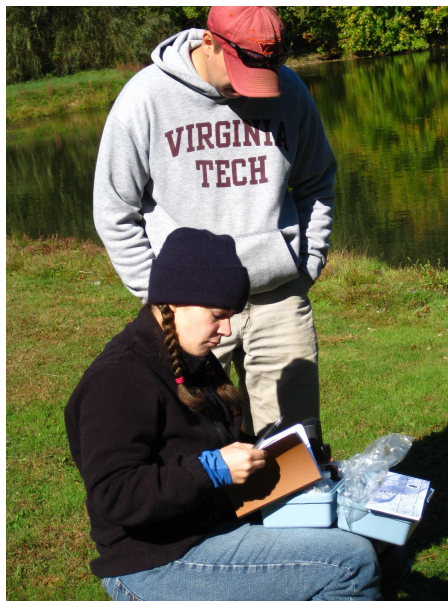
Several water samples were also tested onsite for dissolved oxygen, pH, and bacteria. The pH levels were in a range from 7.8-10, dependent on the area of the pond that was tested (western edge, middle of pond, eastern edge), and were deemed to be within acceptable ranges. The dissolved oxygen (DO) readings varied from 9.4-10, which also were considered to be in a normal range. Dissolved oxygen readings evaluate the amount of oxygen available for organisms. DO has an inverse relationship to BOD in that when the demand for oxygen is high, DO readings are low due to organisms taking in large amounts of oxygen. Measurements of DO can be highly variable depending upon the time of day and the time of year.

Virginia Valentine uses a test kit to measure pH and Dissolved Oxygen (D.O.) at Avon Hall Pond. Photo by Pat Dorsey
